# Manhole Inspection Summary

Manhole # S31G\_\_019MH

Insp Date: **11/12/08 10:26 AM**

**Location** Address: **29 s green st**

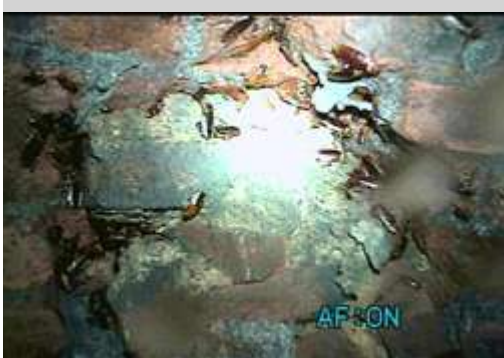
Defect 4

Condition: ☐ Sound ☐ Cracked ☐ Root Intrusion ☐ Loose Brick ☒ **Deteriorated**

barrel

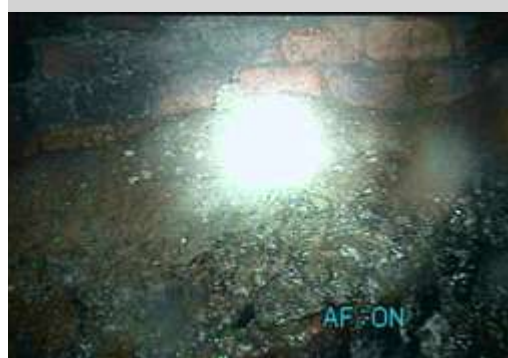
Defect 3

Condition: ☐ Sound ☐ Cracked ☐ Root Intrusion ☐ Deteriorated ☐ Leaks ☒ **Debris**

bench debris

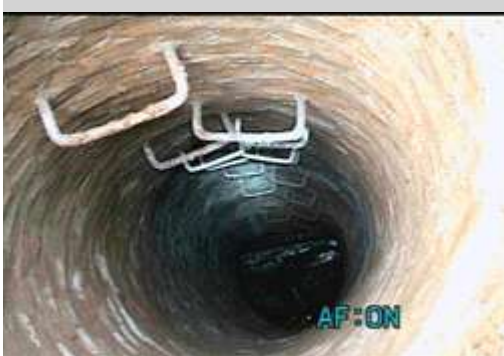
Defect 2

Count: **20** Missing: **0** ☒ **Corroded**

steps corroded

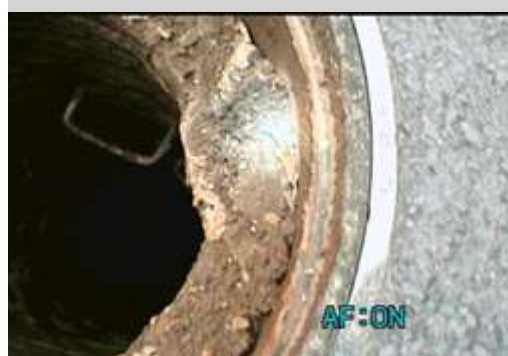
Defect 1

Offset: **6** (in.)

frame offset 6 inches
